# CORROSION BEHAVIOR OF THE 8090-T851 ALUMINUM ALLOY

Abdulbaset A. Frefer and Ali M. Hatab

Department of Mechanical and Industrial Engineering,  
Al-Fateh University, Tripoli-Libya

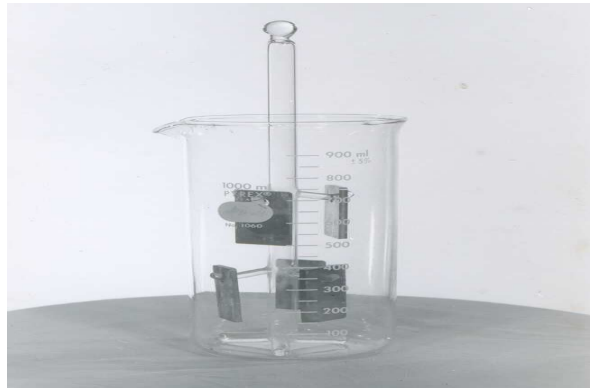
**Figure 1: Glass rack carrying corrosion specimens immersed in 1 liter 3.5% NaCl solution adjusted to a desired pH.**

were weighed to the nearest milligram using a Mettler Instrument Corporation balance. The corrosion specimens mounted on a glass rack, and each rack carried six specimens. The glass rack with coupons was immersed in a beaker containing a solution of the desired pH as shown in Figure (1).

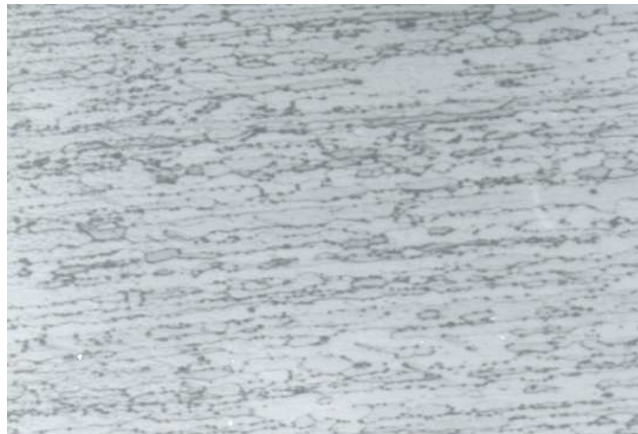
**Figure 2: Optical micrograph showing the fine dispersion of particles along the grains and subgrain boundaries of the 8090-T851 alloy in the longitudinal direction (275x).**

The optical microscopy reveals partially recrystallized grain structure with unrecrystallized grains elongated parallel to the extrusion direction (due to cold working) of the plate. A fine dispersion of particles distributed in the grain and subgrain boundaries as shown in Figure (2). The microstructure of 8090-T851 was discussed in details

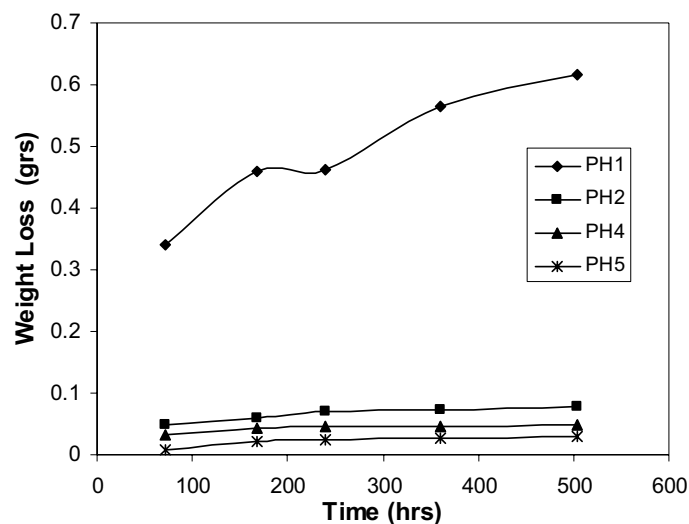
**Figure 3: Variation of weight loss with time of 8090-T851 alloy in 3.5% NaCl solution adjusted to pHs 1, 2, 4, and 5.**

Figure (3) shows clearly that the weight loss of the specimen in solution of pH1 is several times greater than the weight loss of the specimens in the solutions of pH2, pH4, and pH5.

It is evident that the weight loss of the specimen in solution of pH1 begins at high rate and progressively increases as time of the testing increases, while the other specimens show a

lower rate of weight loss. The weight loss of the alloy specimens results from uniform attack and localized attack on the active lithium bearing phases present in the alloy [18,19], the grain boundary precipitates [20], and the high angle and low angle boundaries [20].

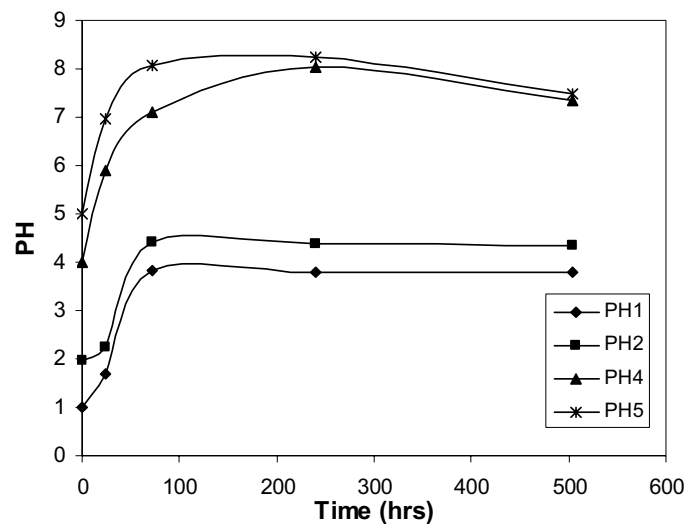
Figure 4: Comparison of the variation of the solution pH with time.

Aluminum is a reactive metal and forms an oxide/hydroxide surface film with water at room temperature. This film protects the aluminum metal from further reaction, and passivating the metal. However, this protective film is affected by the acidity or alkalinity of the solution and the presence of other ions such as chloride in the solution. Figure (4) shows the variation of the pH of the corrosion solutions with time.

The pH of solutions of pH1 and pH2 increases to approximately the starting level of pH4 within 100 hours after the corrosion specimens are immersed, indicating that active corrosion of aluminum alloy took place, which can be represented by aluminum dissolution and hydrogen evolution reactions:

Similar behavior happens with solutions of the pH4 and pH5 that change in the same interval toward a common value of approximately the starting level of pH7.5. The corrosion was slow due to the formation of oxide/hydroxide film on the metal surface, and the cathodic reaction became as oxygen reduction rather than hydrogen evolution:

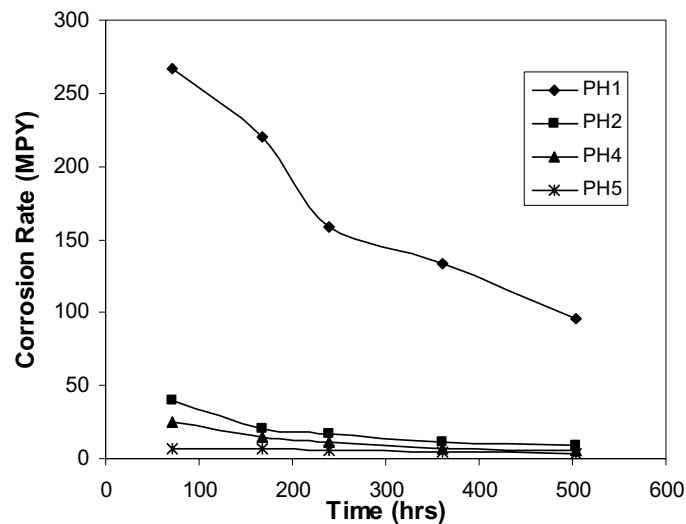
Figure 5: Variation of corrosion rate with time of all specimens in all solutions.

In all acidic solutions, the corrosion rate decrease with time as shown in Figure (5), indicating that the more hostile the solution, the higher the corrosion rate.

The corrosion rate of pH1, pH2, and pH4 start at higher rates during the first days of immersion, and then progressively decrease through out the testing period, which are in good agreement with the initial high rates of weight loss that have occurred in this type of environment. However, the corrosion rate of pH5 starts at a low rate during the first days

of testing and then stays almost constant latter. The higher corrosion rate in the acidic solutions is resulted in uniform corrosion, pitting, and intergranular attack throughout the exposure period, while the decrease in the corrosion rate is attributed to the formation of a protective film, and shift in solution pH level [15]. Pitting corrosion may be attributed to the Cl<sup>-</sup> in the solution, especially at high pH values of 4 and 5, where the passive film may form on the metal surface.

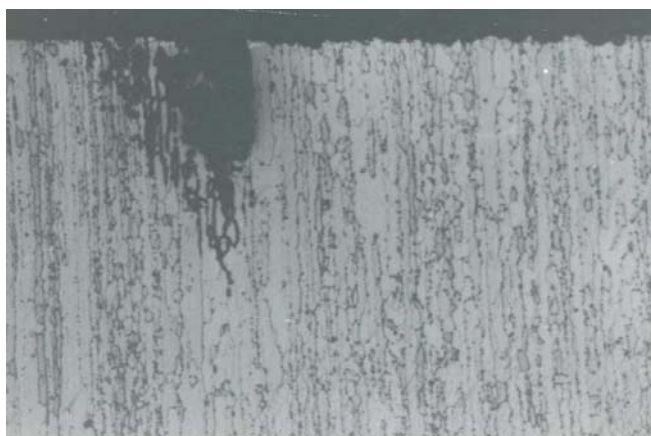
**Figure 6: Optical micrograph of the cross section of alloy 8090 after immersion in solution of pH 5 for 360 hours showing a large pit with intergranular attack (275x).**

Intensive examination of the surface and cross sections of the corrosion specimens at both low and high magnification show the types of corrosion that occur to the alloy 8090-T851 in this investigation. Uniform general corrosion, the most destructive form is observed clearly after immersion in solution of pH1. This form of corrosion is characterized by an evenly distributed attack over the alloy surface. Pitting after immersion in all solutions, and the degree of attack is higher for specimens in solutions of pH1 and pH2 as shown in Figures (6 and 7). An intergranular attack is characterized by attack along the grain and subgrain boundaries of the alloy.

This mechanism causes deep local penetration and rapid destruction of the mechanical properties of the alloy, and occurs for all specimens. The degree of attack is higher for more acidic than for the mild ones, pH1 is suffered the most, then pH2, pH4, and pH5 respectively. This is in agreement with the weight loss and corrosion rate that occur for the specimens in all solutions. The pits that form are caused by an accelerated dissolution of the passive film and the metal substrate.

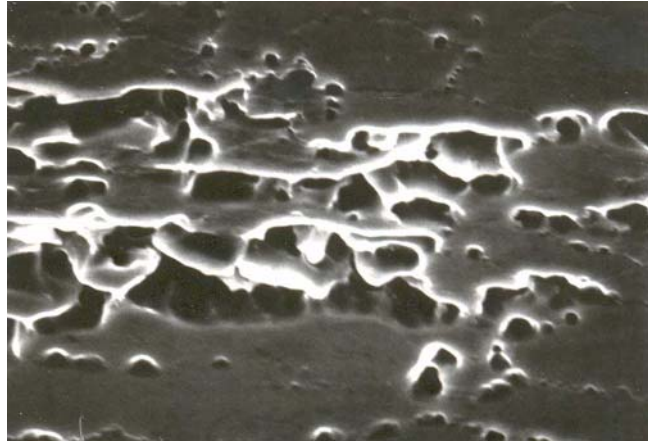
**Figure 7: Scanning electron micrograph of the surface of alloy 8090 exposed to solution with pH1 for 120 hours showing pits attacking the particles along the grain and subgrain boundaries (2000x).**

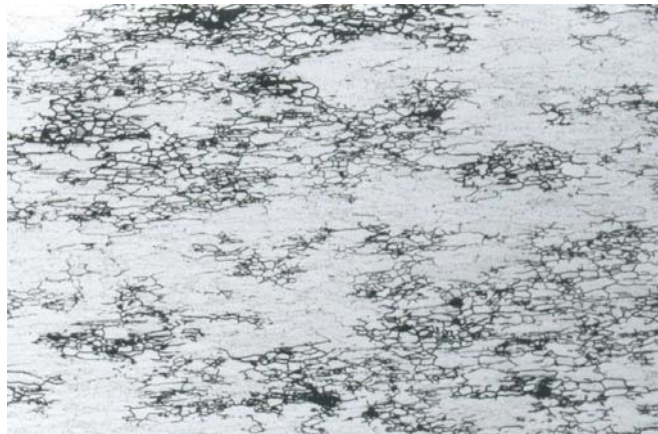
**Figure 8: Optical micrograph of the surface of alloy 8090 after immersion in solution of pH1 (275x).**

The mode of corrosion is intergranular attack. The degree of the attack increased both with increasing aggressiveness of the solution and the exposure time to the solution. The intergranular attack that occurs in the specimens immersed in the solutions of pH1 is the most severe than pH2 and pH5 as shown in Figures (8,9 and 10) respectively.

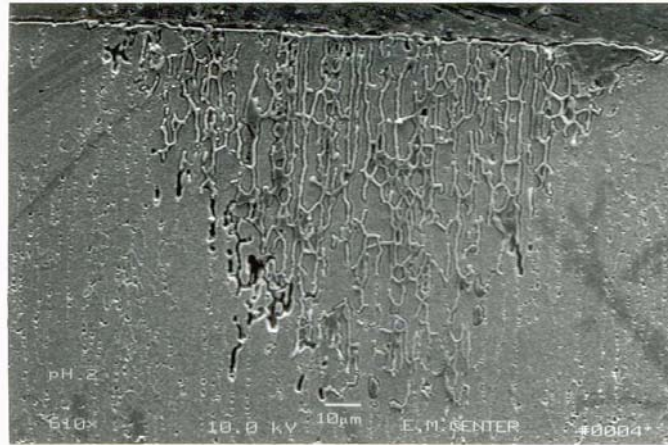
**Figure 9: Scanning electron micrograph of the cross section of alloy 8090 exposed to solution with pH2 for 360 hours showing the degree of intergranular attack (610x).**

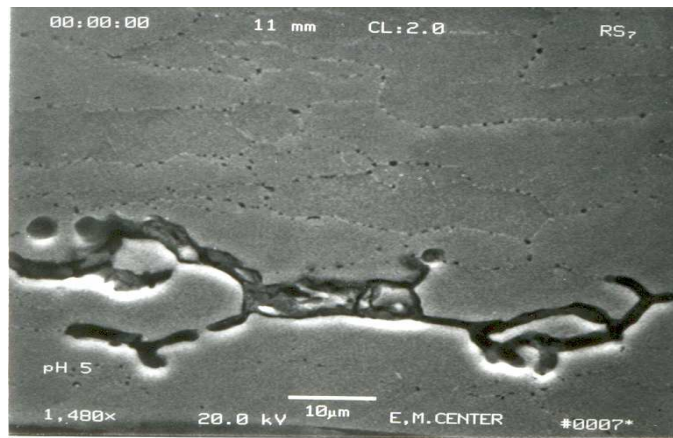
**Figure 10: Scanning electron micrograph of the surface of alloy 8090 exposed to solution with pH5 for 360 hours showing the degree and path of intergranular attack (1480x).**
